FIRCREST COMMUNITY CENTER

PRE-DESIGN ASSESSMENT AND PLANNING STUDY

JULY, 2016

PREPARED FOR CITY OF FIRCREST

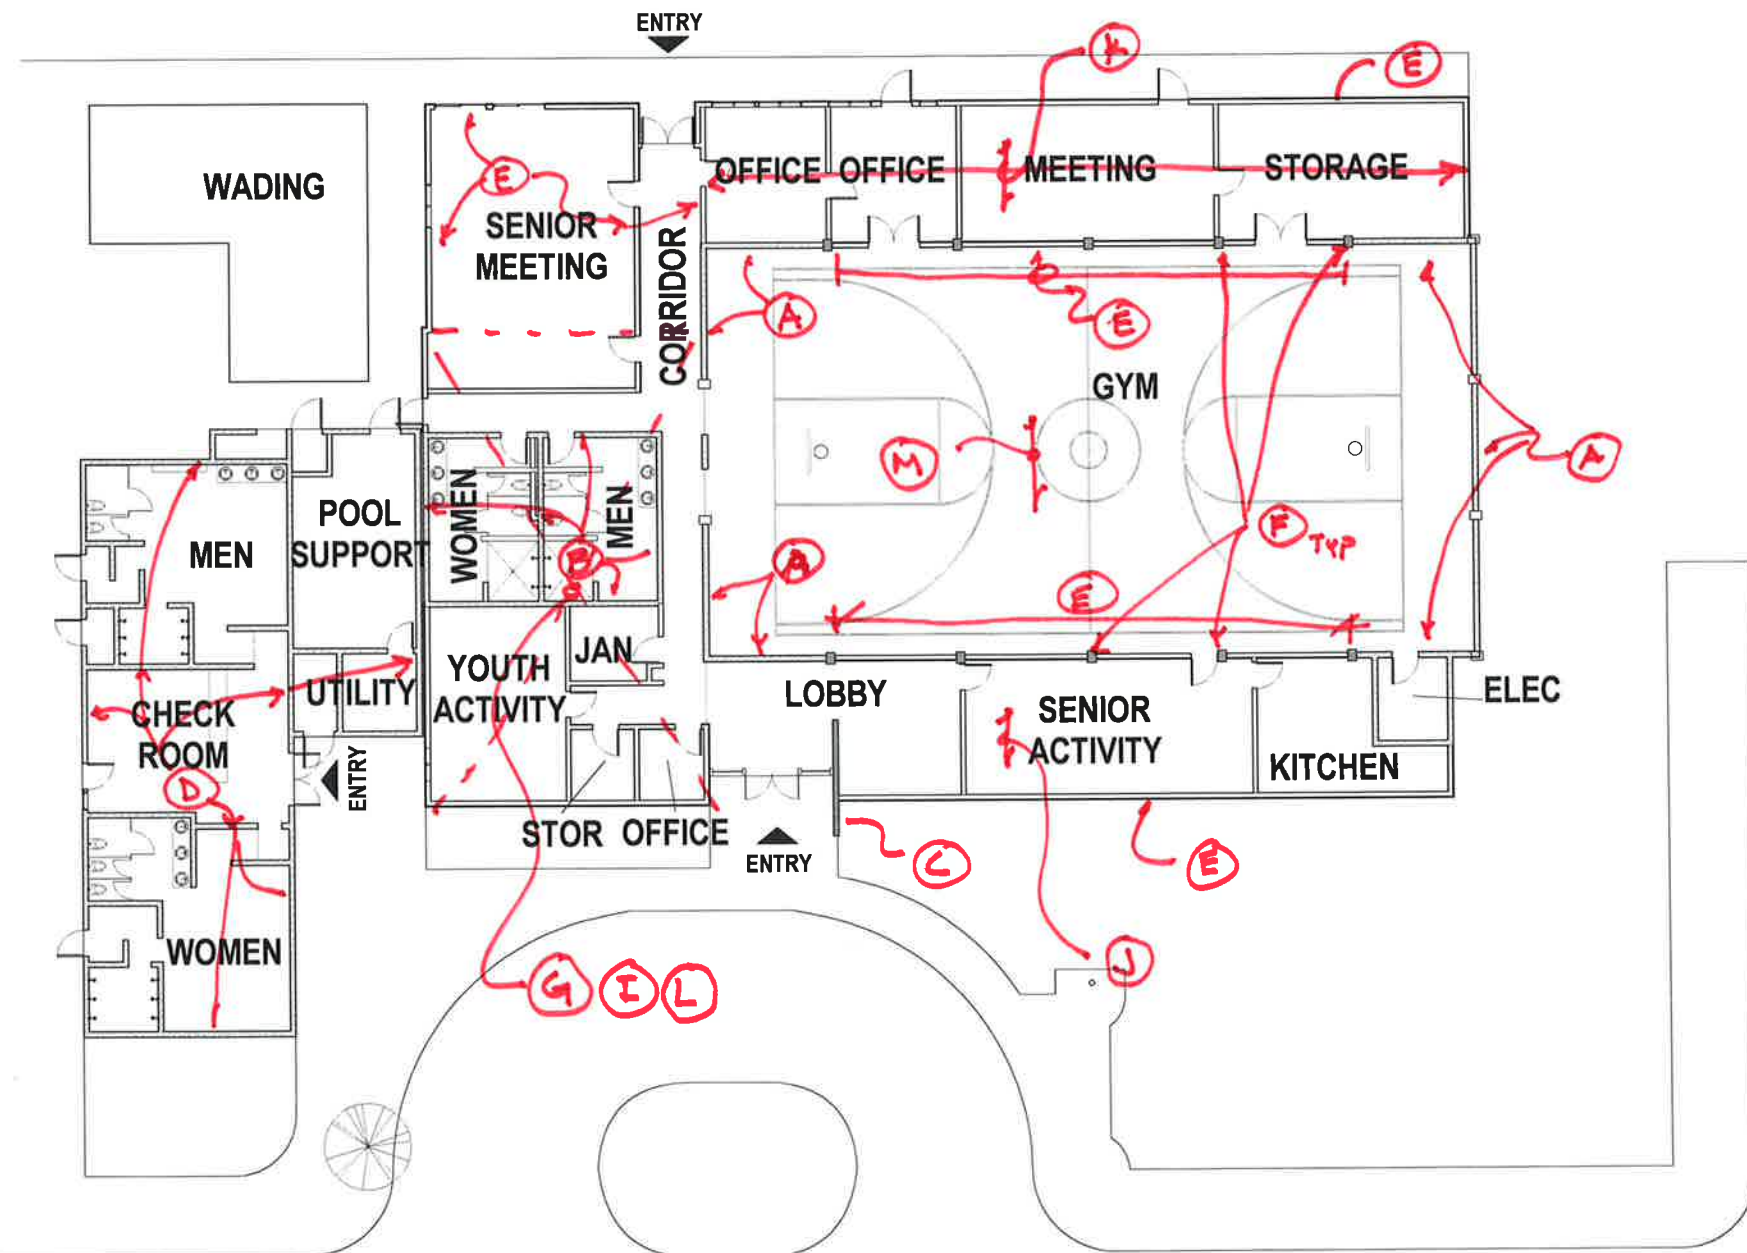
- A. Existing CMU walls with vertical and horizontal reinforcing. There is reinforcing although not reinforced per today's standards.
- B. Existing CMU walls with marginal reinforcing. Will treat as unreinforced masonry walls.
- C. Reinforced concrete wall.
- D. CMU walls not tested. Reinforcing unknown.
- E. Wood framed walls.
- F. Wood columns supporting wood roof beams above.
- G. Wood crawl space.
- H. Concrete slab on grade floor construction.
- I. Wood roof framing currently serving as an attic space.
- J. Wood roof beams with joist or decking above.
- K. Unknown wood roof framing. Assume wood roof trusses.
- L. Overbuilt wood roof framing.
- M. Assumed overbuilt wood roof framing over gym.
