November 14, 2017

Serial Letter #001

RE. Fircrest Community Pool Evaluation

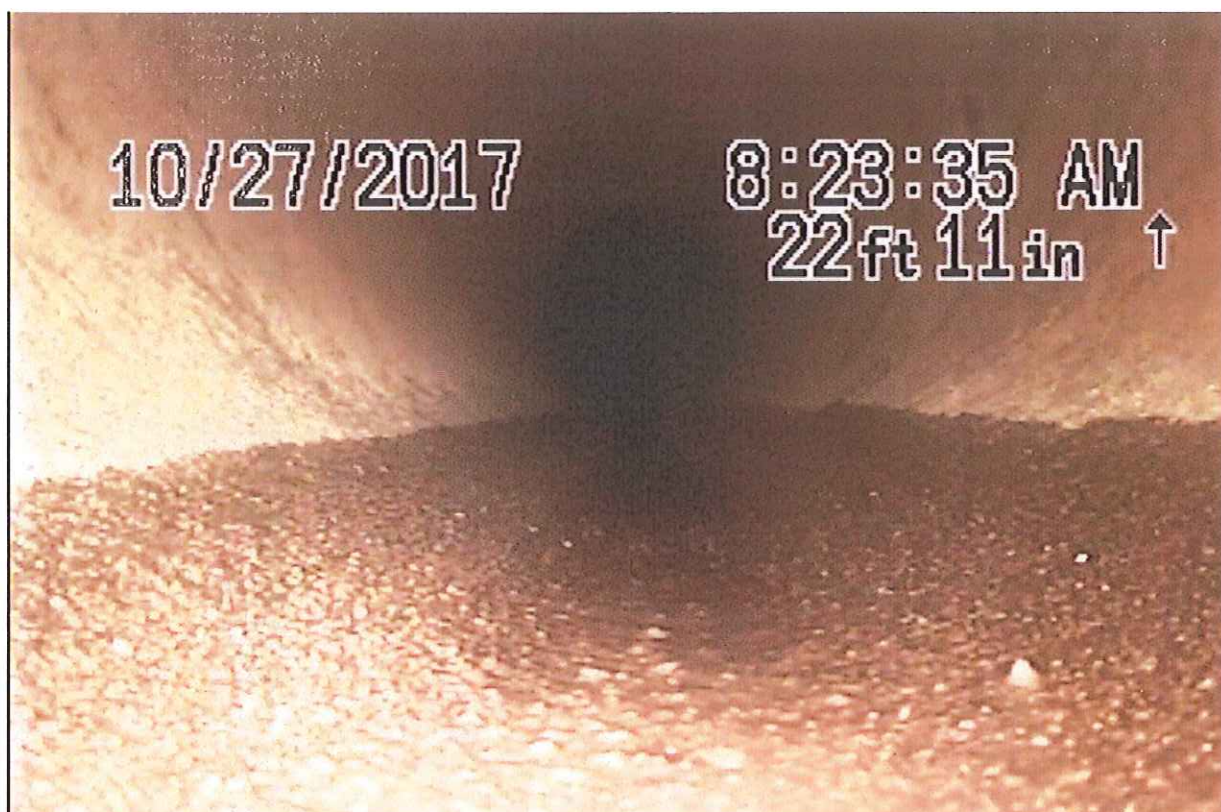
The above screen shot from the video is an example of a good section of pipe as a frame of reference for the next two screen shots which show blockages.

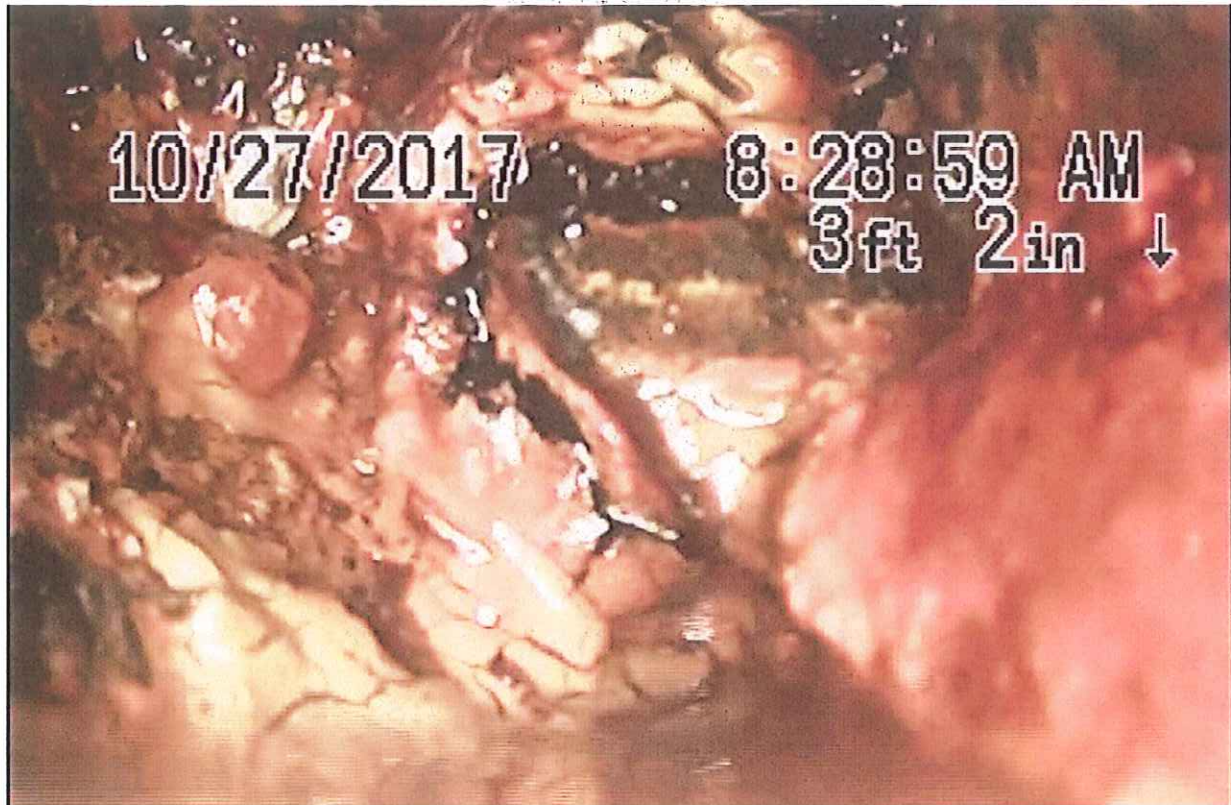
The above picture is the blockage at approximately 3 feet into the drain pipe from the bottom of the pool. The camera was able to be pushed up and over this blockage. The amount of debris in the pipe shows this is a significant break in the pipe that needs to be fixed. This area later in the video showed flowing water which leads us to believe the flowing water is actually ground water entering the pool system.

- 1) Lower 90 degree fitting broken
 - a. Remove concrete at deck level
 - b. Cut pipe and install a cleanout at upper 90 degree fitting. Approximately 30” to 36” deep.

- i. This will allow a crew to jet down the pipe to the drainage structures to clean the debris from the pipe
 - ii. This will also allow (if feasible) access for a slip lining company to perform their work to patch the pipe

- c. Jet the pipe down to the catch basins at the bottom of the pool. The catch basins will allow the debris to be collected and removed.
 - d. Video the line again in order to determine if slip lining the broken area of pipe will be feasible.

- e. If slip lining will work proceed with slip lining
- 2) Upper blockage near pool equipment room
 - a. Remove concrete deck.
 - b. Dig down and find pipe. Approximately 30” to 36” deep.

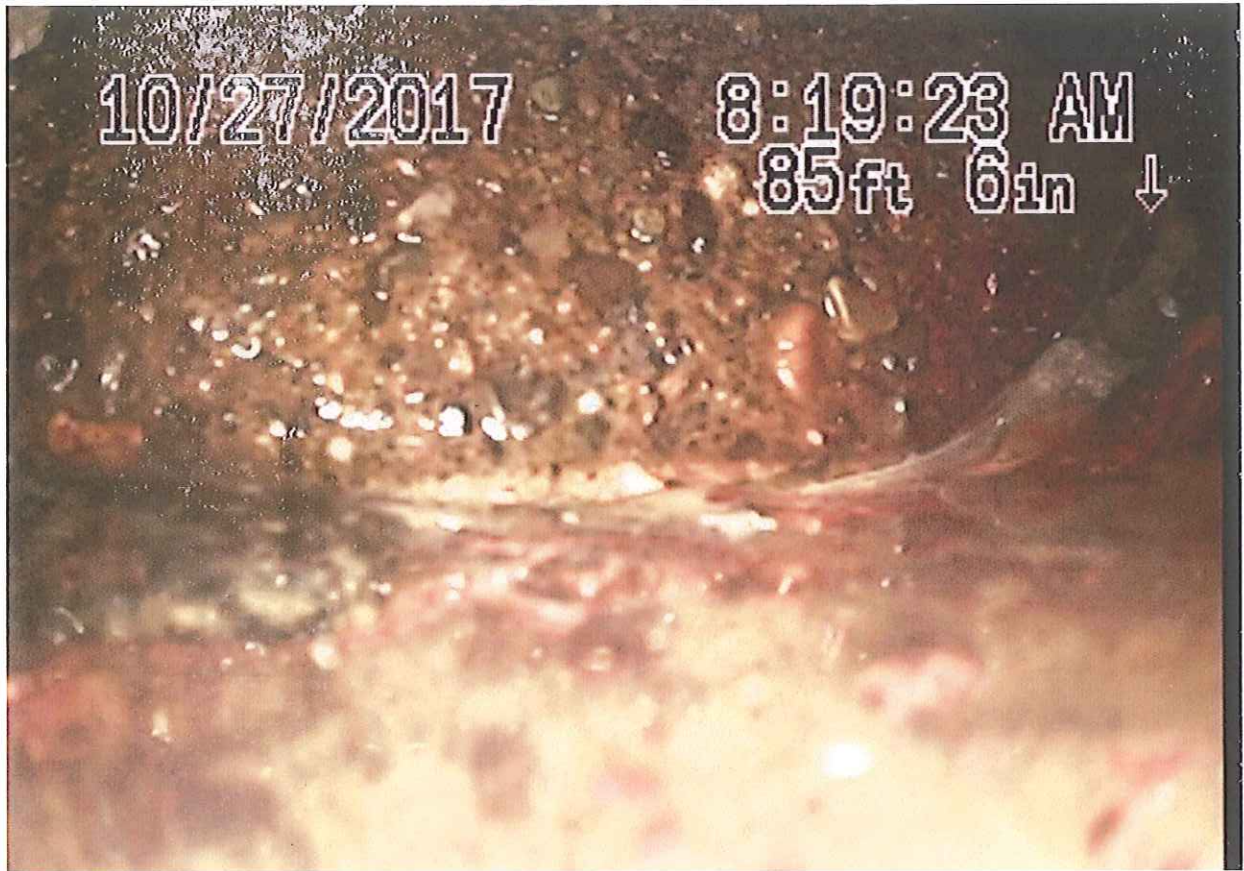
The above picture is a screen shot of the video at approximately 85 feet from the pool. This puts this obstruction at near the 90 degree fitting to the pool equipment room. You can see the rock and debris clogging the pipe. The camera was not able to get past this obstruction to finish the pipe run. This large amount of debris is only possible due to a large break in the pipe.

- c. Fix pipe
 - d. Replace concrete deck.
- 3) Broken concrete deck near pool
 - a. Remove existing broken concrete
 - b. Investigate sub-grade for any possible clues/ extent of void
